DEBRIS/ICE/TPS ASSESSMENT  
AND  
PHOTOGRAPHIC ANALYSIS  
OF  
SHUTTLE MISSION STS-32R

January 9, 1990

Gregory N. Katnik  
NASA/Kennedy Space Center  
TV-MSD-22

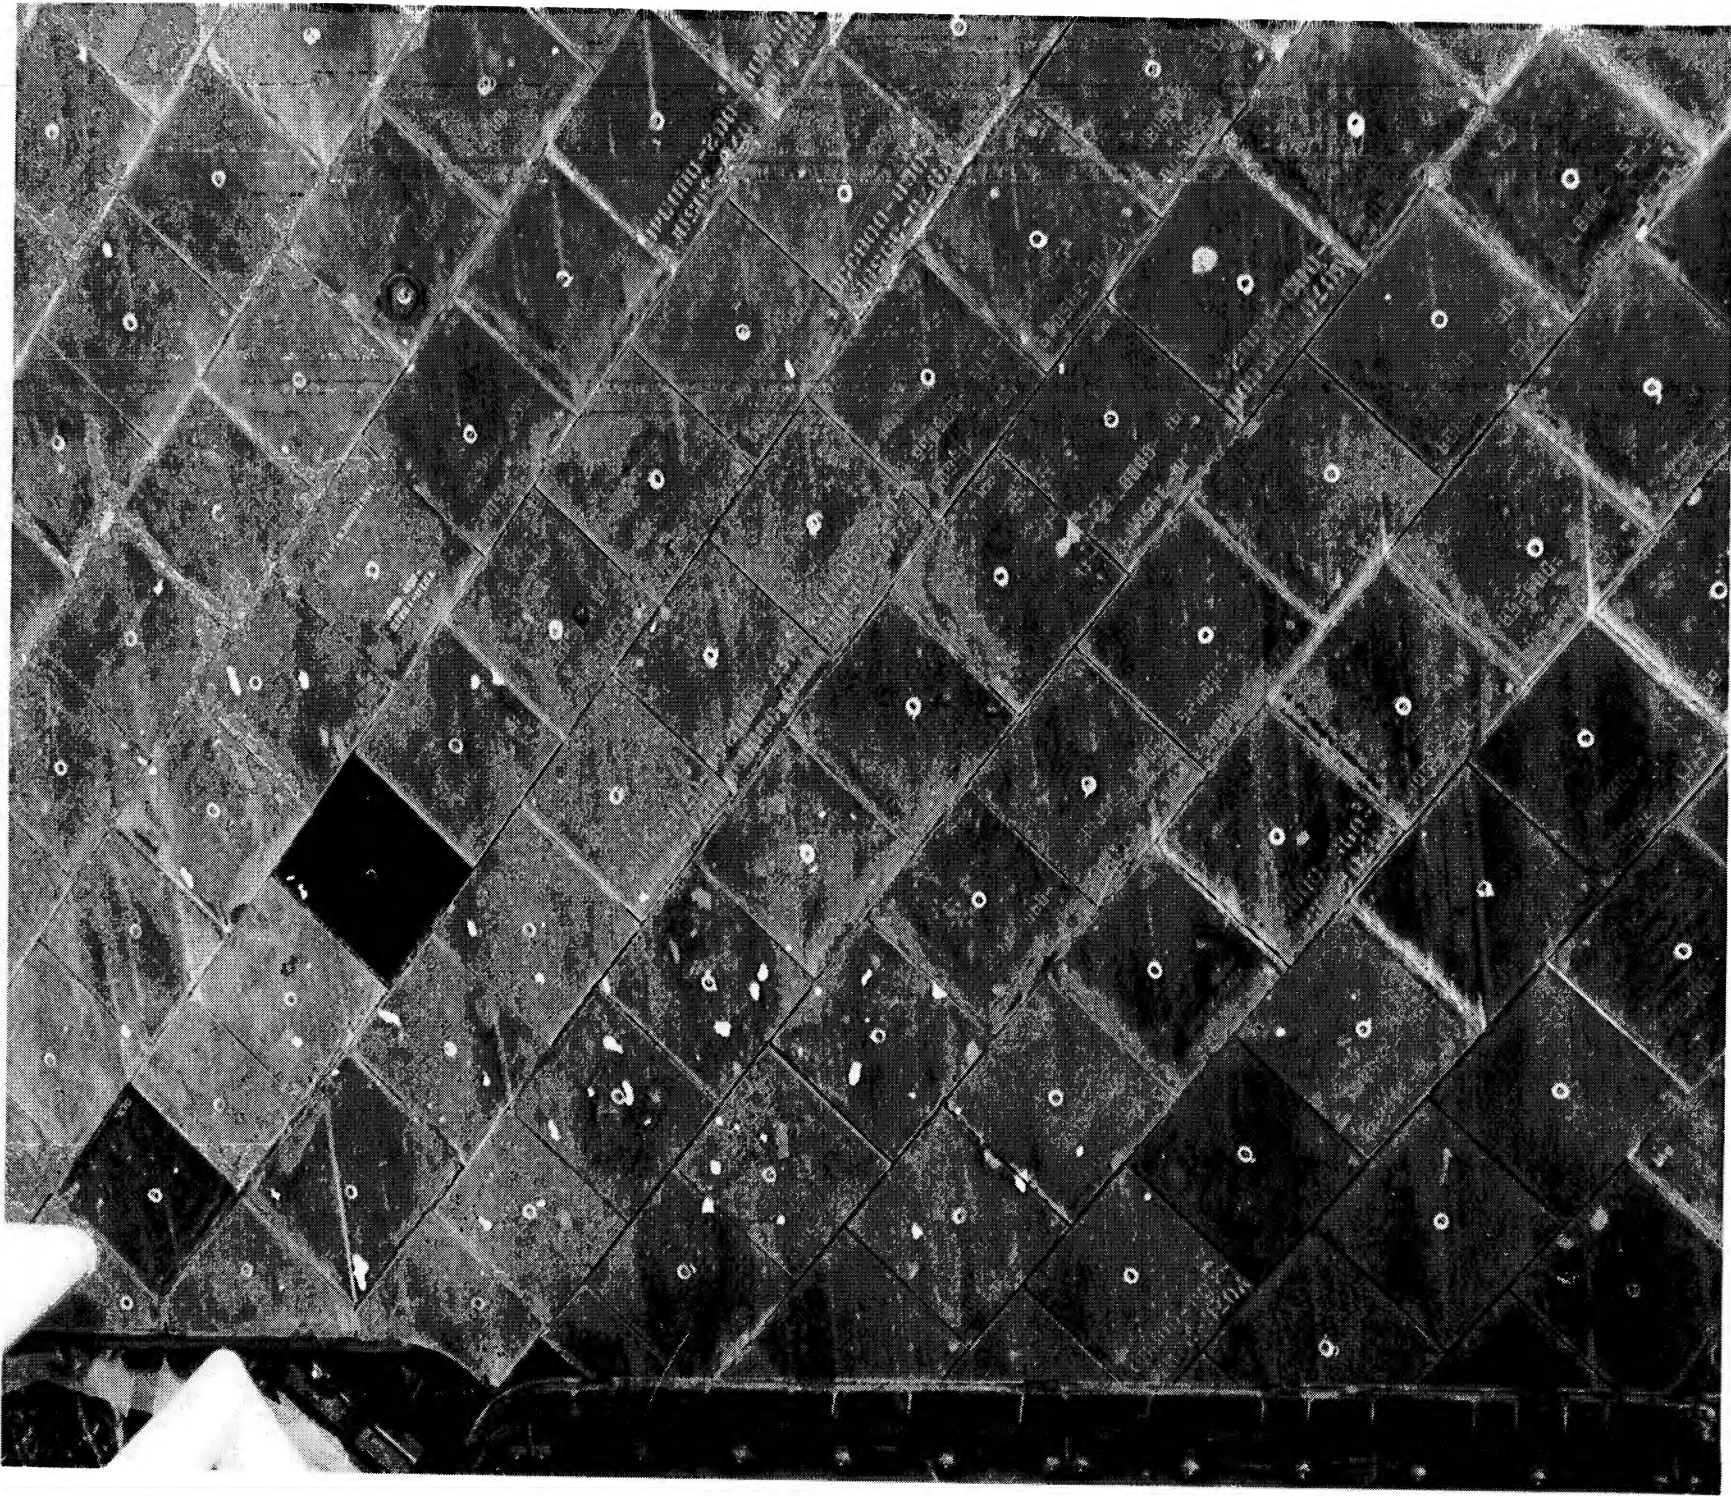
Cluster of lower surface tile damage aft of the LH2 ET/ORB  
umbilical is typically caused by ice impacts

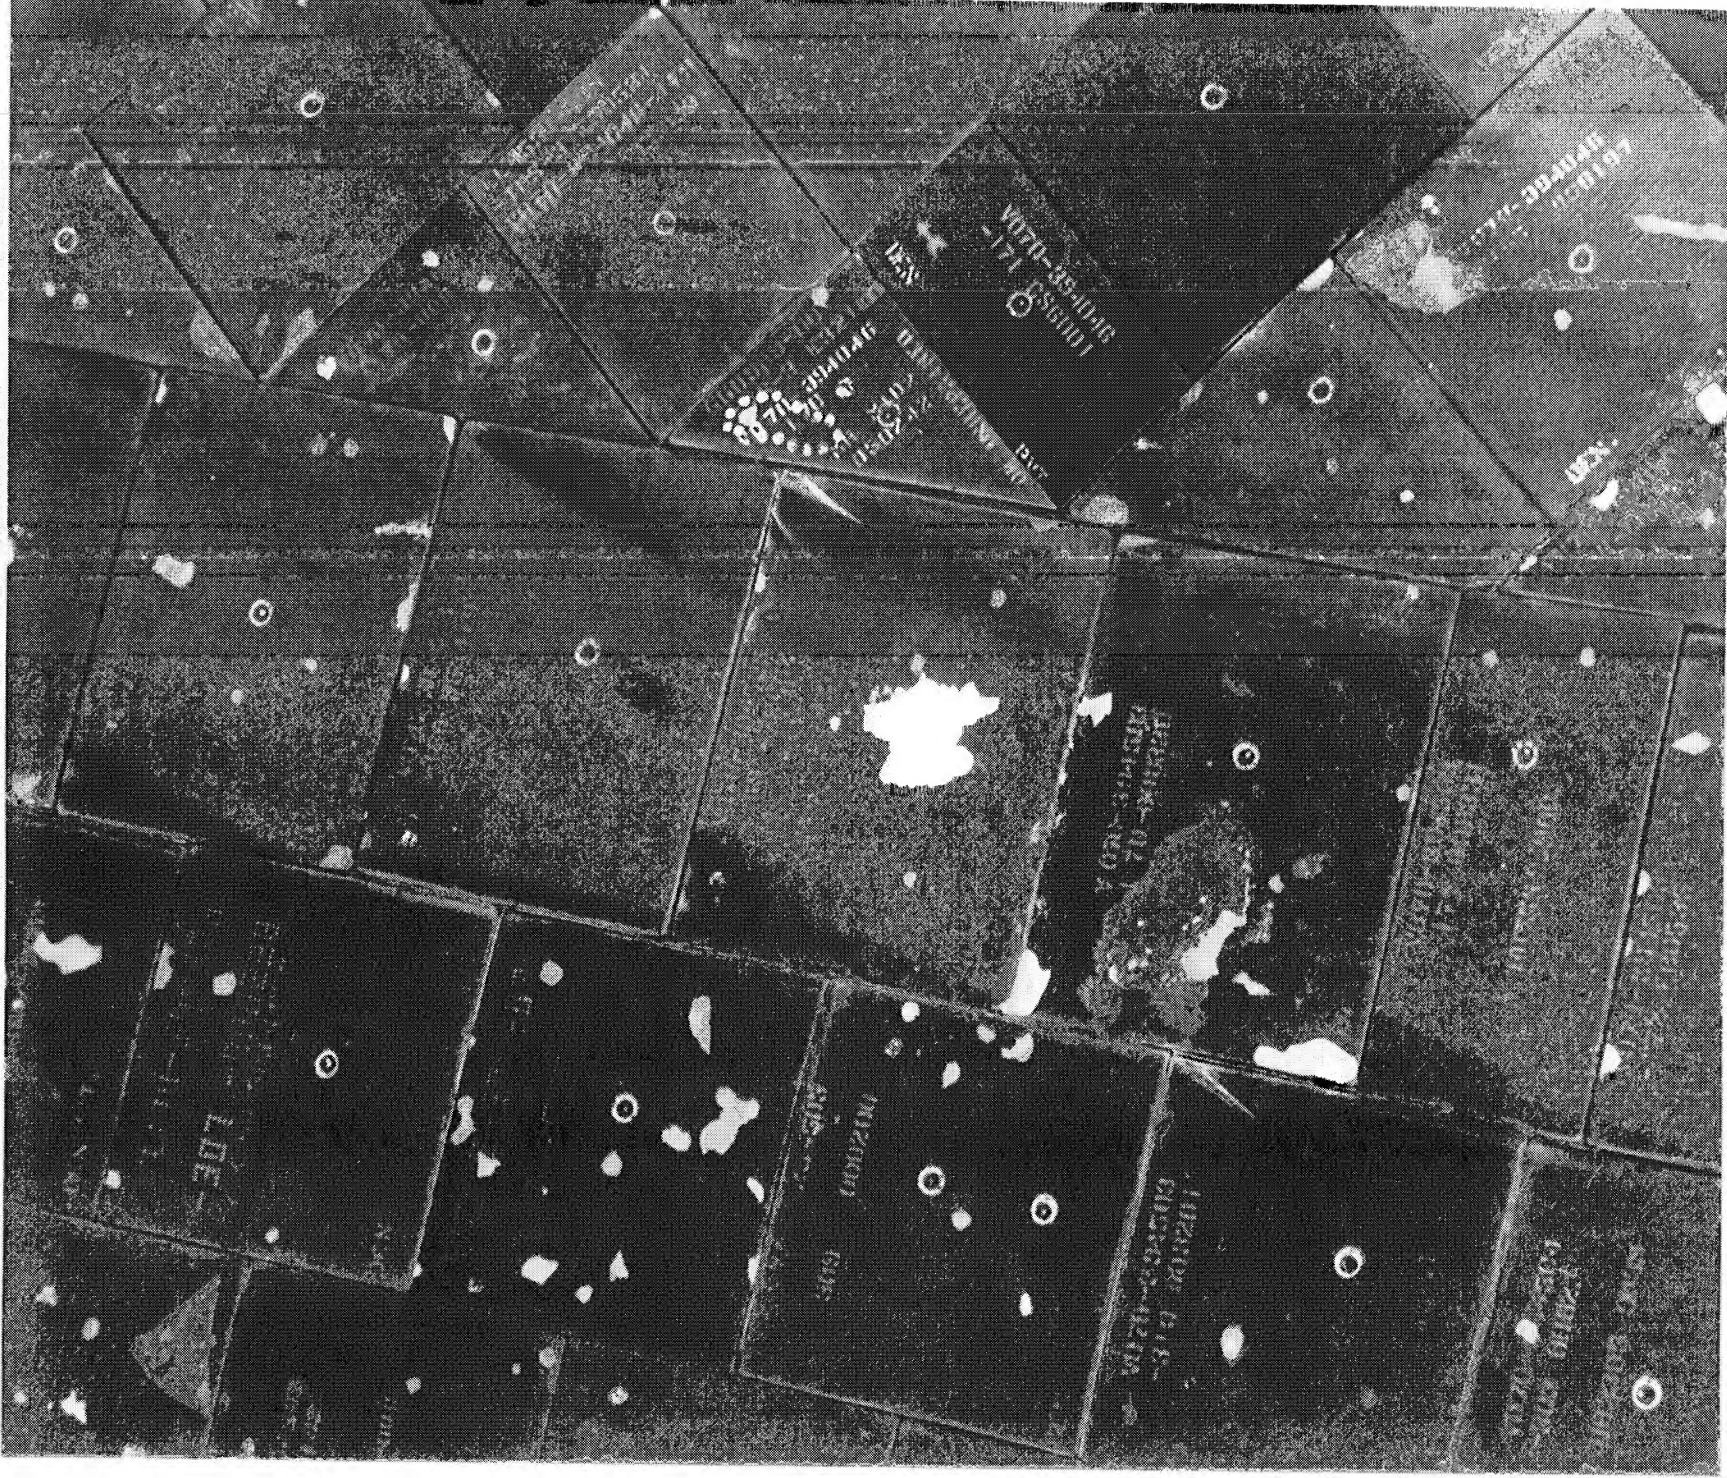
Typical impact-type damage to tile surface. Note numerous repairs to small areas in surrounding tiles.

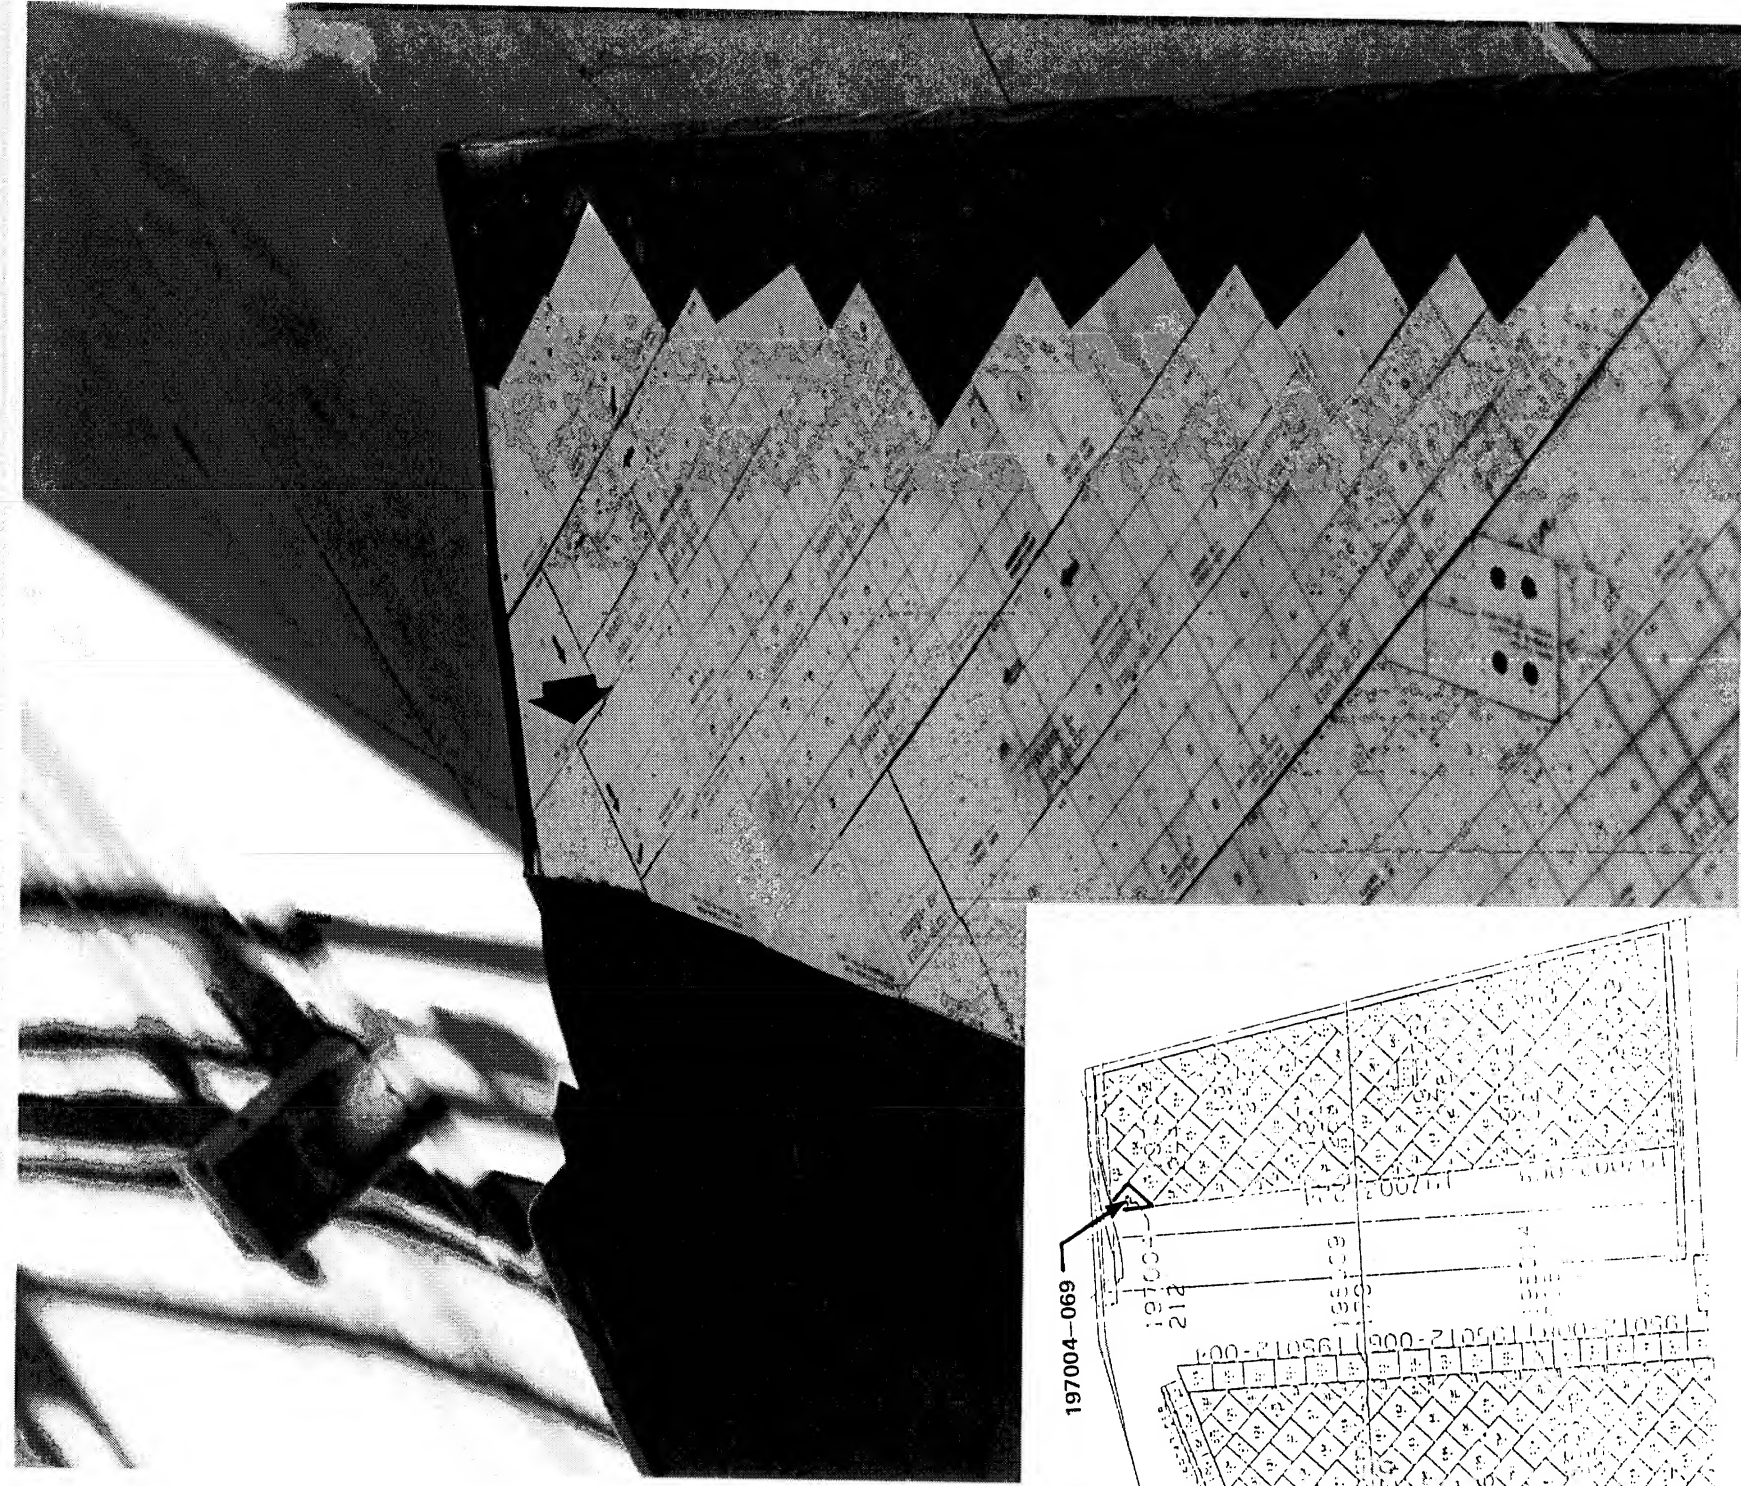
White tile screed repair missing from RH outboard elevon was visible in launch films falling from the vehicle

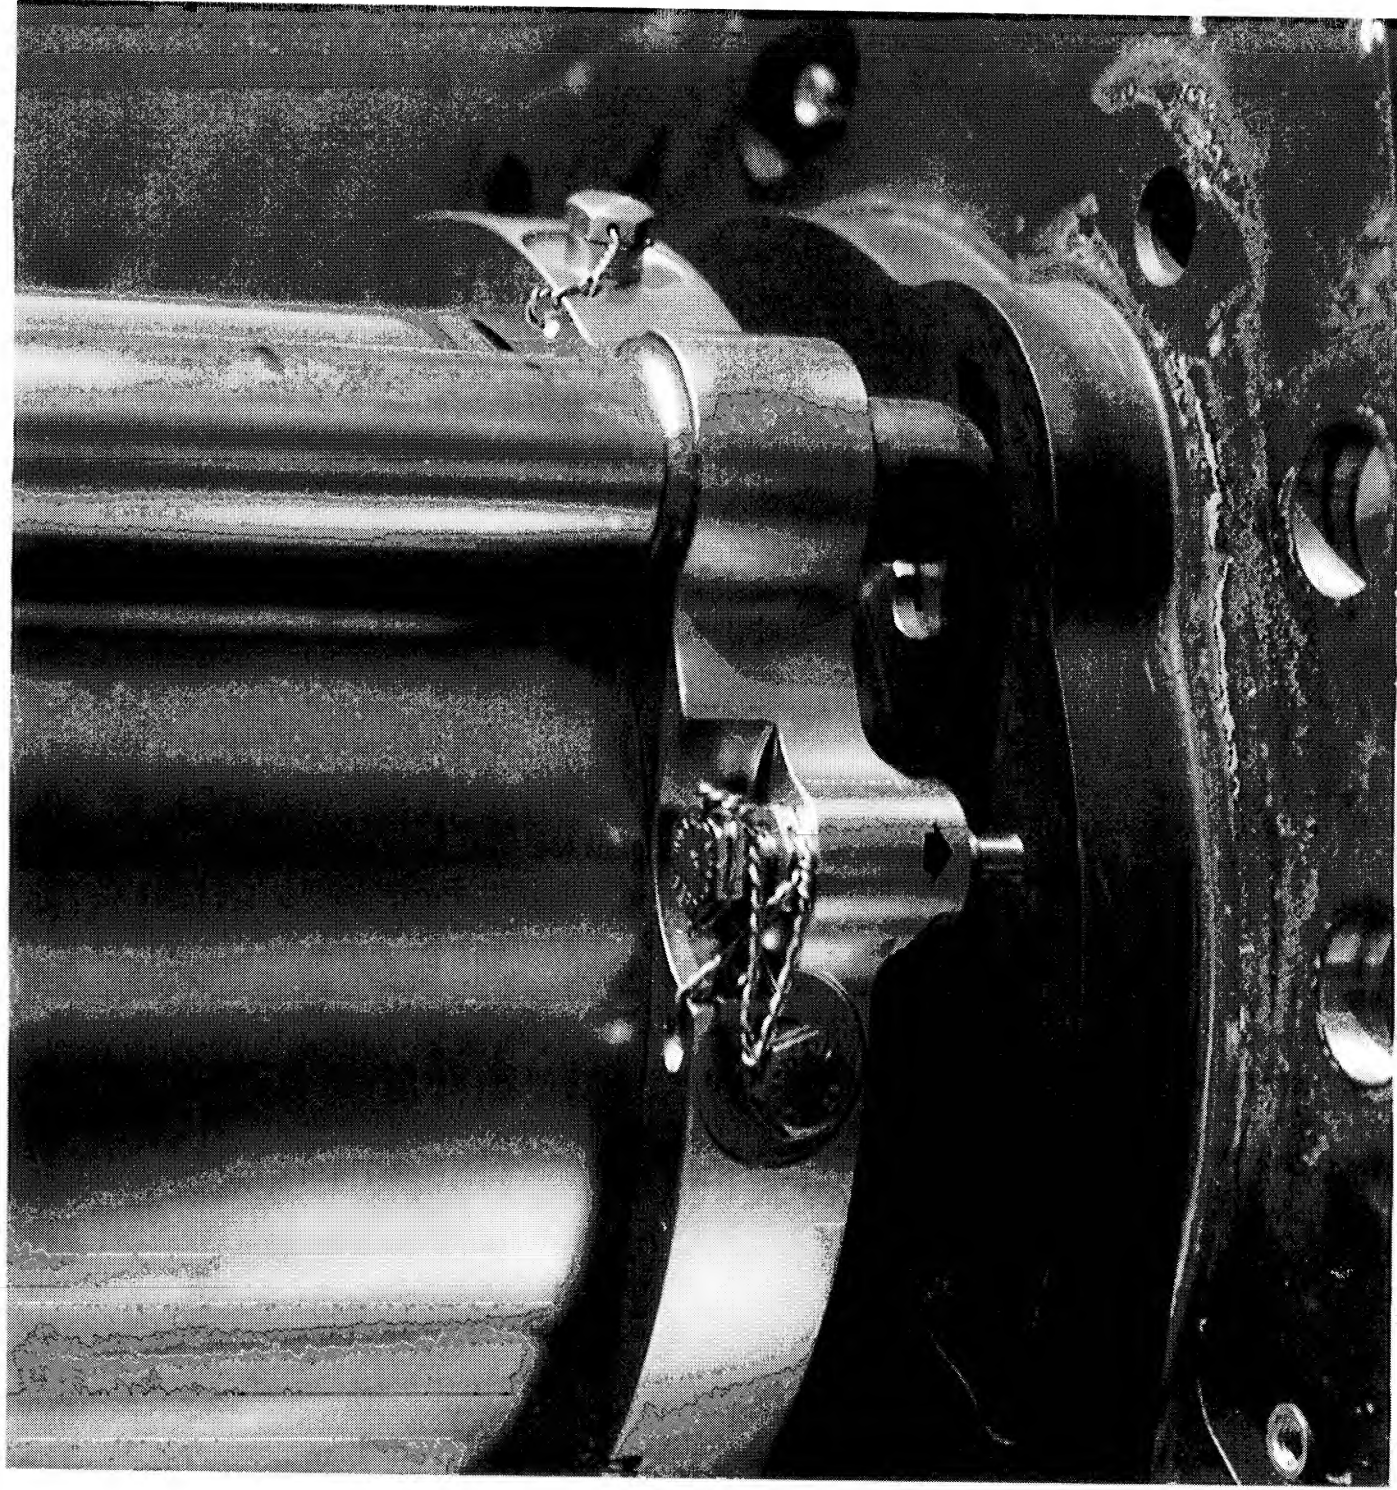
backshells, as evidenced by scratch marks on the ordnance device spring housings. The backshells were not broken as in STS-33R. The RH Y-Y centering bolt, which had bent on STS-34, showed signs of compressive loading.

Post flight examination of EO-1 attach point revealed  
compressive loading damage to RH Y-Y centering bolt
